CaneSIG: Modelling Loco Depots

Qunaba Mill's Loco Sheds

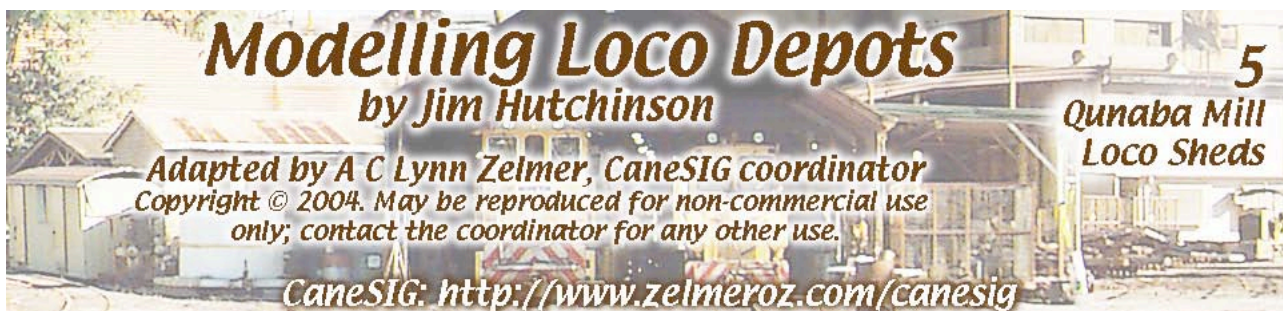
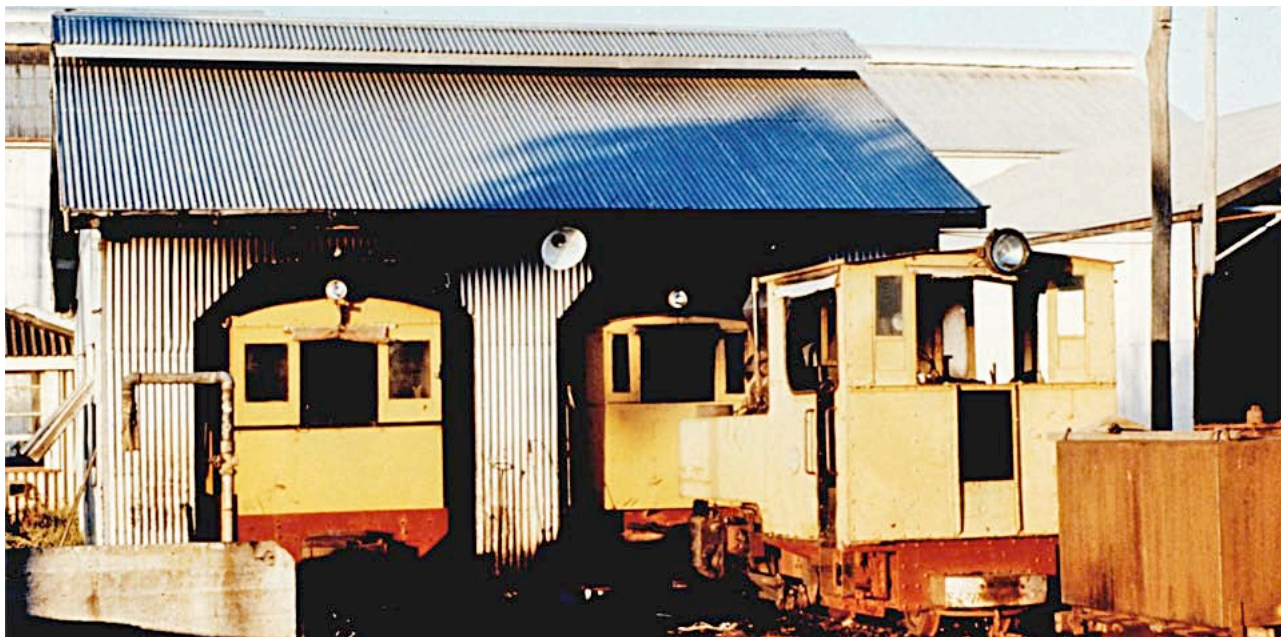
Qunaba Mill loco shed, c 1968 (above) and the newer shed in the same location, 1975 (below); David Mewes photos.

The former (1968) steam shed at Qunaba was one example of a corrugated asbestos-cement (fibro) structure. It apparently had a minimum loading gauge (see the 1968 David Mewes photo on the previous page) that suited the then-current locomotive fleet. The 'based-on' 1968 drawings have been distorted by increasing the clearance (and the building) height to accommodate diesel loco outlines.

The later shed appeared to be more open and taller than its predecessor. Photographs, such as the bottom photo on the first page, indicate that it was being used by both steam and diesel locomotives as late as 1975.

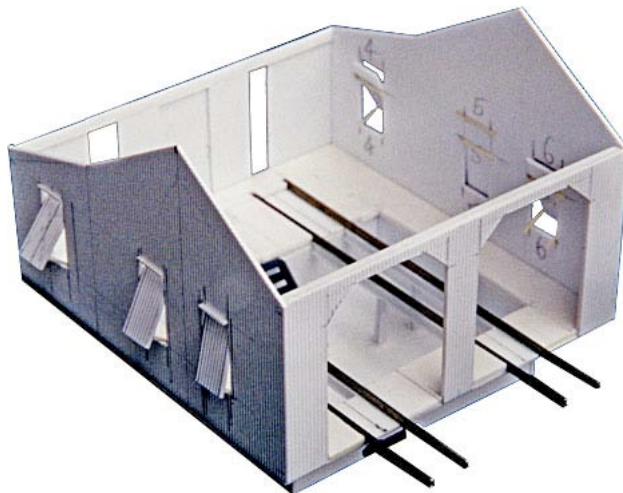
The supporting beams under each rail are 1/8" I or H sections, 3/32" H section was used for the supporting struts. The stair into the pit is a Plastruct product, although this could have been scratch-built.

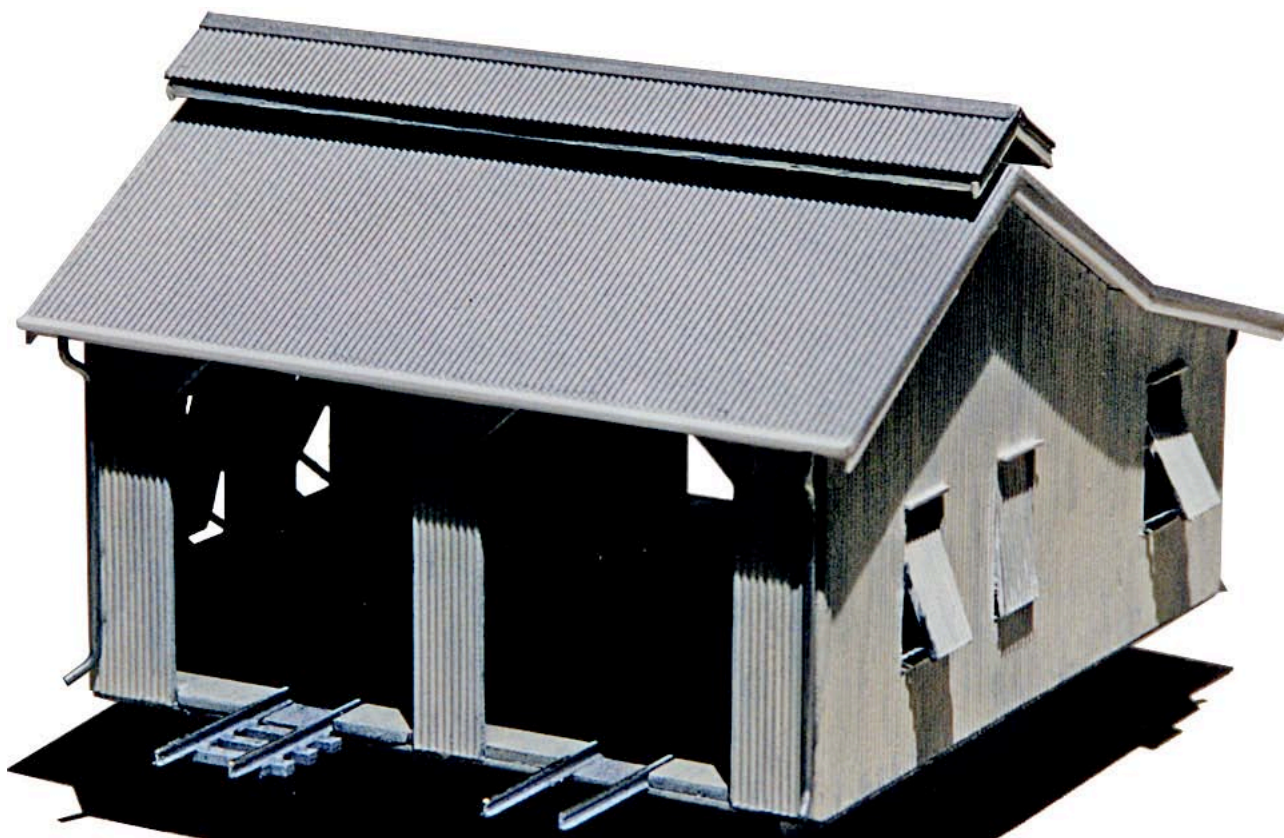
The 'based-on' 1968 two road loco shed with higher doors and roof to accommodate diesel locomotives. In HO this model is small enough, and the interior enclosed enough, that framing and other interior detailing are not required. In larger scales the model could be built with a pole framework, timber girts and metal cladding. Model and model photos by Jim Hutchinson.

Being a relatively enclosed structure interior visibility is limited, so styrene (metal siding 40 thou spacing) seemed an appropriate HO scale modelling medium

for the walls and roof. The vented ridge was also formed from flat sheets, and 30 thou styrene was used for the pit and floor. Use of this material eliminates the need to fabricate wall and roof frames, so the whole model can be assembled fairly easily and quickly.

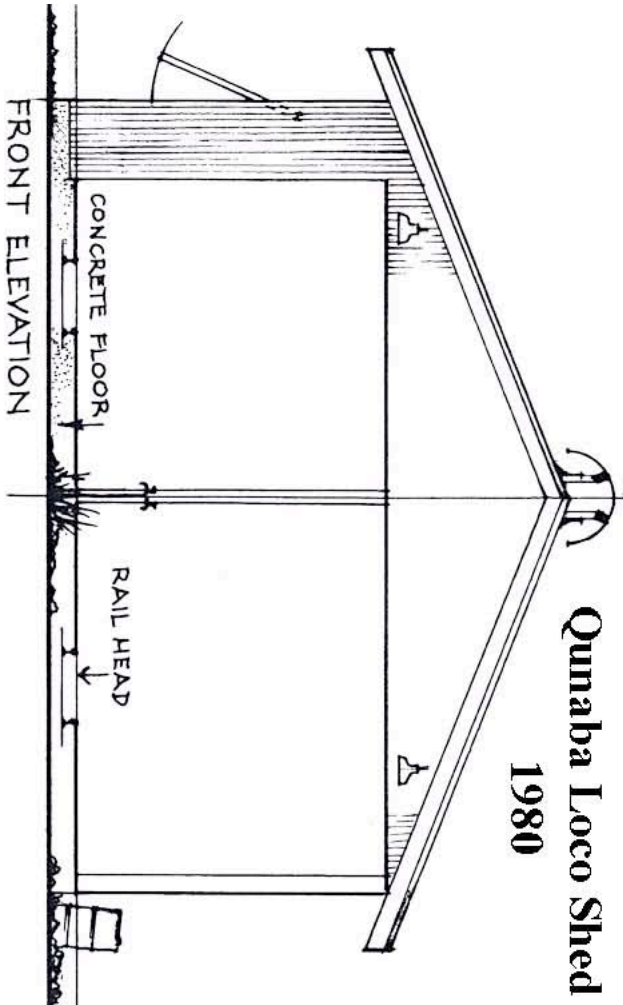
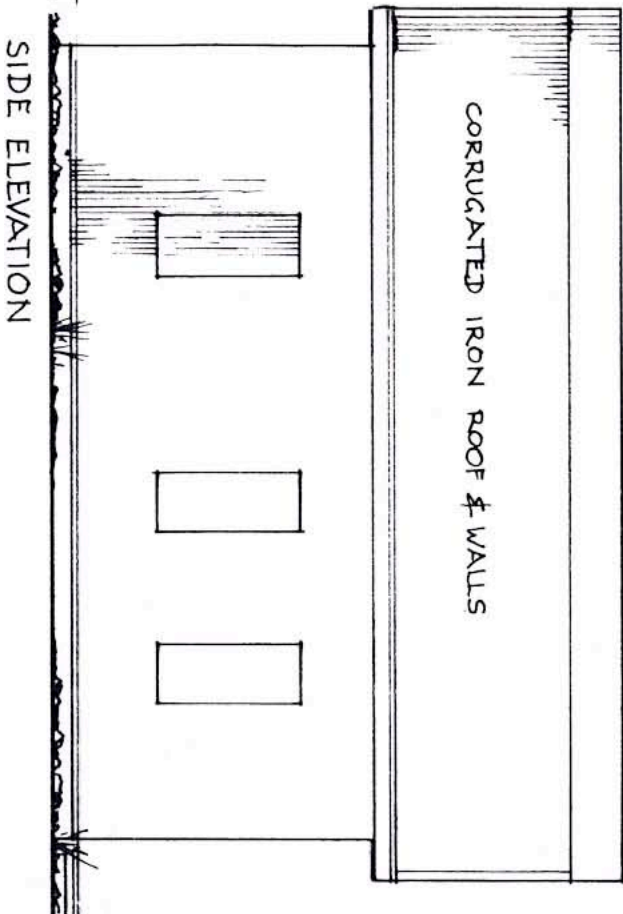
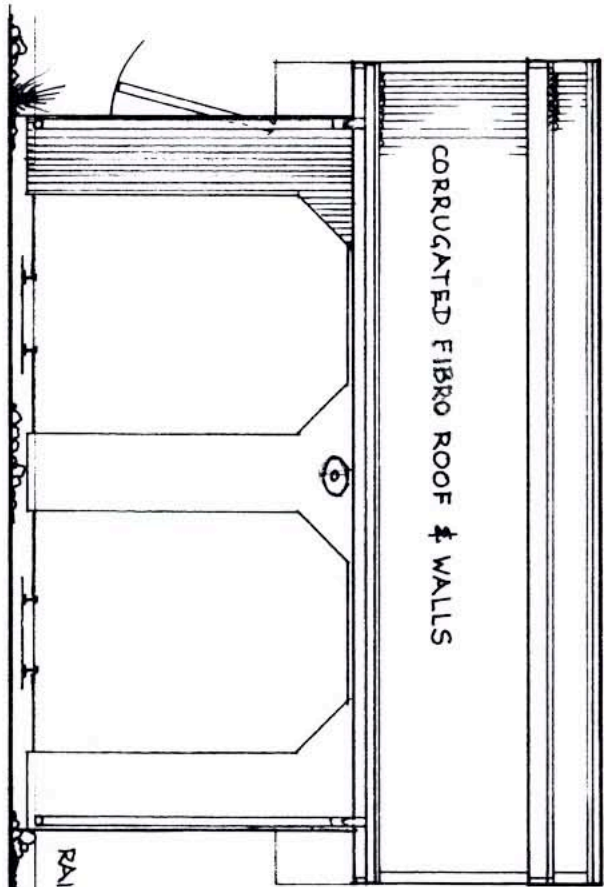
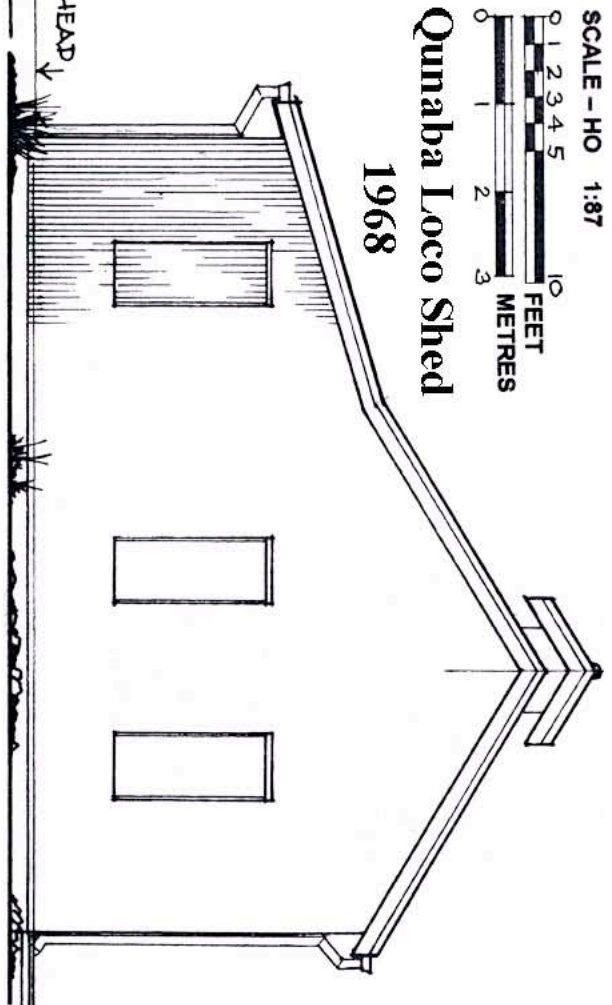
Qunaba Loco Shed
1968

Jim Hutchinson's drawings on the next page show the two loco sheds, remembering that the 1968 shed has had its doors and roof heightened to accommodate diesel locomotives.

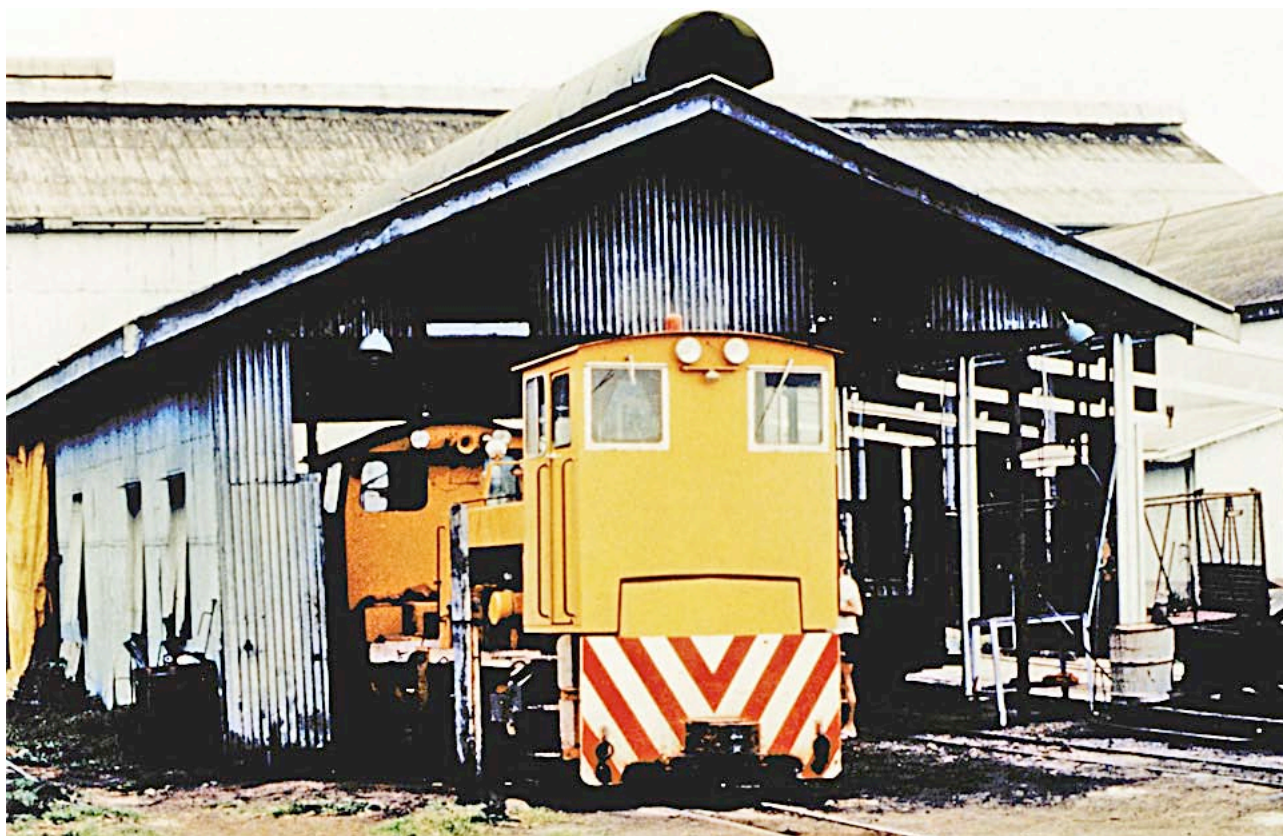
Greg Stephenson photo, c 1980.

The 1980 structure could have been framed with steel members; and the model uses 3/32" styrene H sections for the columns with styrene strips for the wall framing. The roof formers and sub-roof were made from 30 thou styrene sheet with corrugated aluminium for the wall cladding and roof. Base construction was similar to that used for the Mourilyan Mill (see *Modelling Loco Depots #6: Model Construction Notes*).

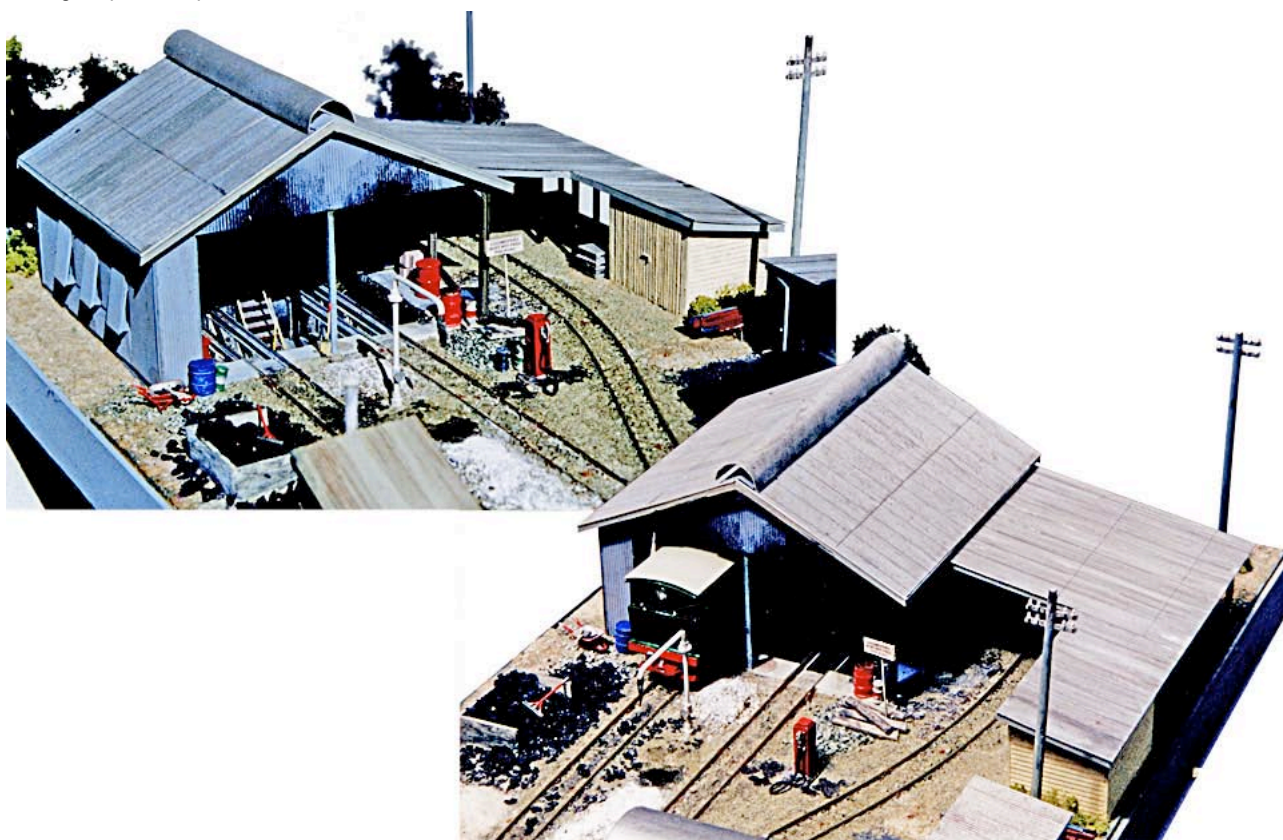
The Quanaba shed model provides a good example of the modelling techniques described in this series and was incorporated into the loco diorama depicted here. The resulting scene demonstrates the value of embellishing the site with appropriate details—loco depots are working areas and a pristine area is far from appropriate. This freelance scene recalls the steam to diesel transition era, which makes it possible to include facilities for each. The concurrent use of coaling and watering facilities along with a fuel bowser and associated tanks (without questioning the safety aspects of such a close relationship!) may thus be justified chronologically, at least in modelling terms. In addition, the basic shed structure has been extended with a skillion roof to incorporate a small bin repair road and miscellaneous storage facilities.

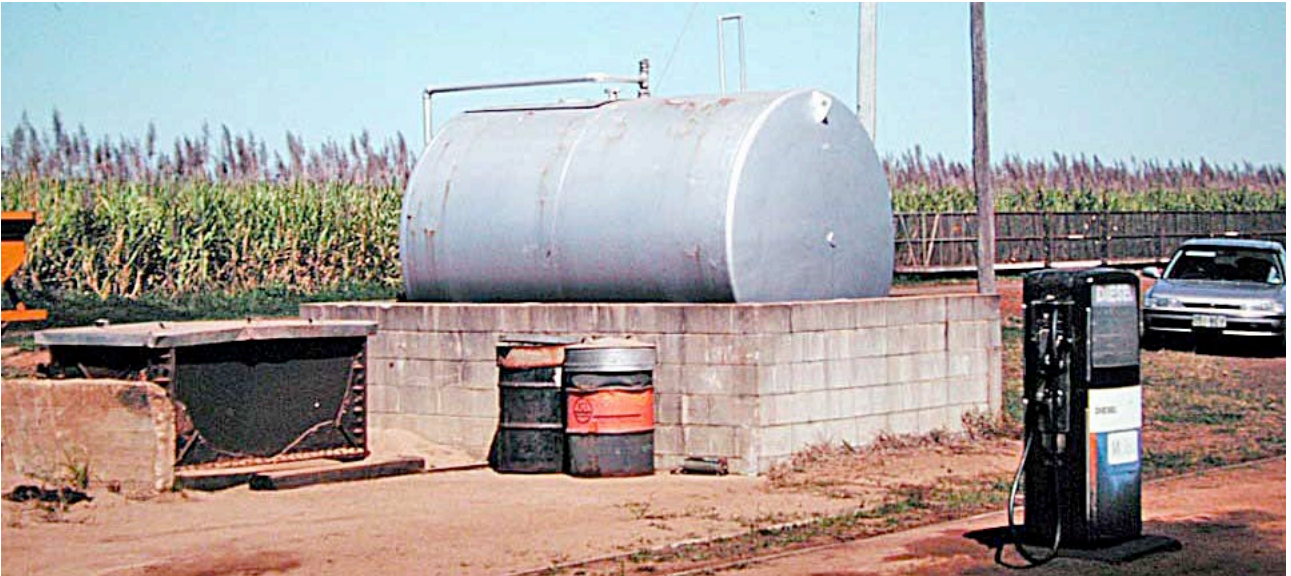
The loco fuel bowser and storage tank with spill containment barrier in 2000. The bowser can be seen in the middle distance through the open shed in the previous photo. Greg Stephenson photo from the CaneSIG collection.
