Railway Goods Sheds (Queensland)

Adapted by A C Lynn Zelmer, CaneSIG coordinator, from clinic notes and provided by Jim Hutchinson and Jim Fainges

Cream Sheds

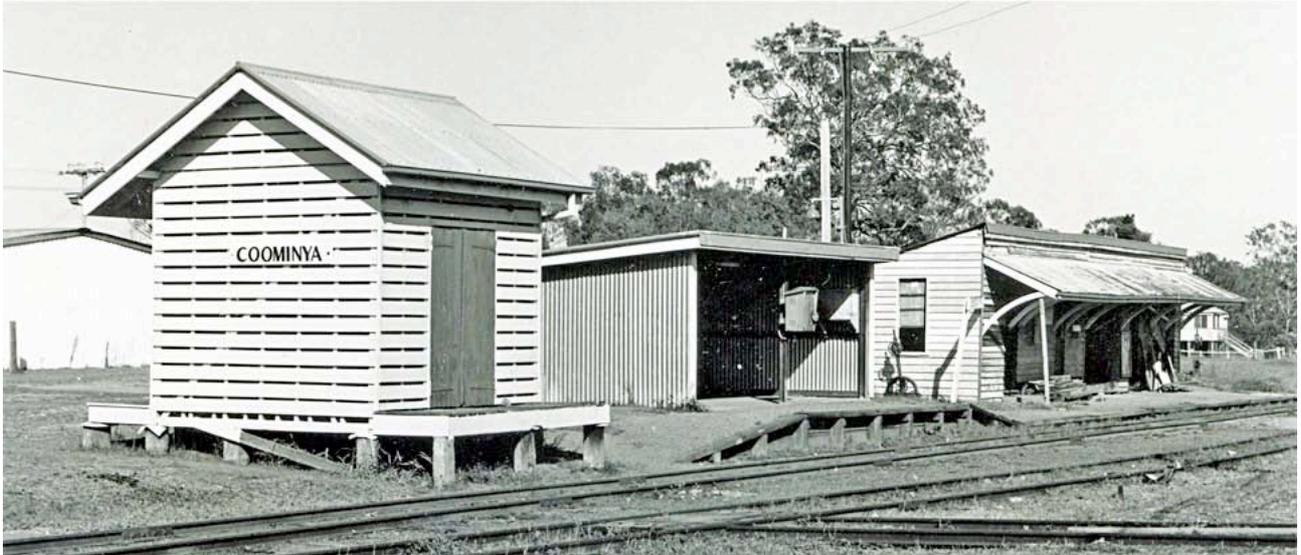
In the final days of the Brisbane Valley branch it appeared that Coominya's cream shed (above) had become the main station building, having the honour of displaying the name-board and being presented as the best maintained of the three buildings.

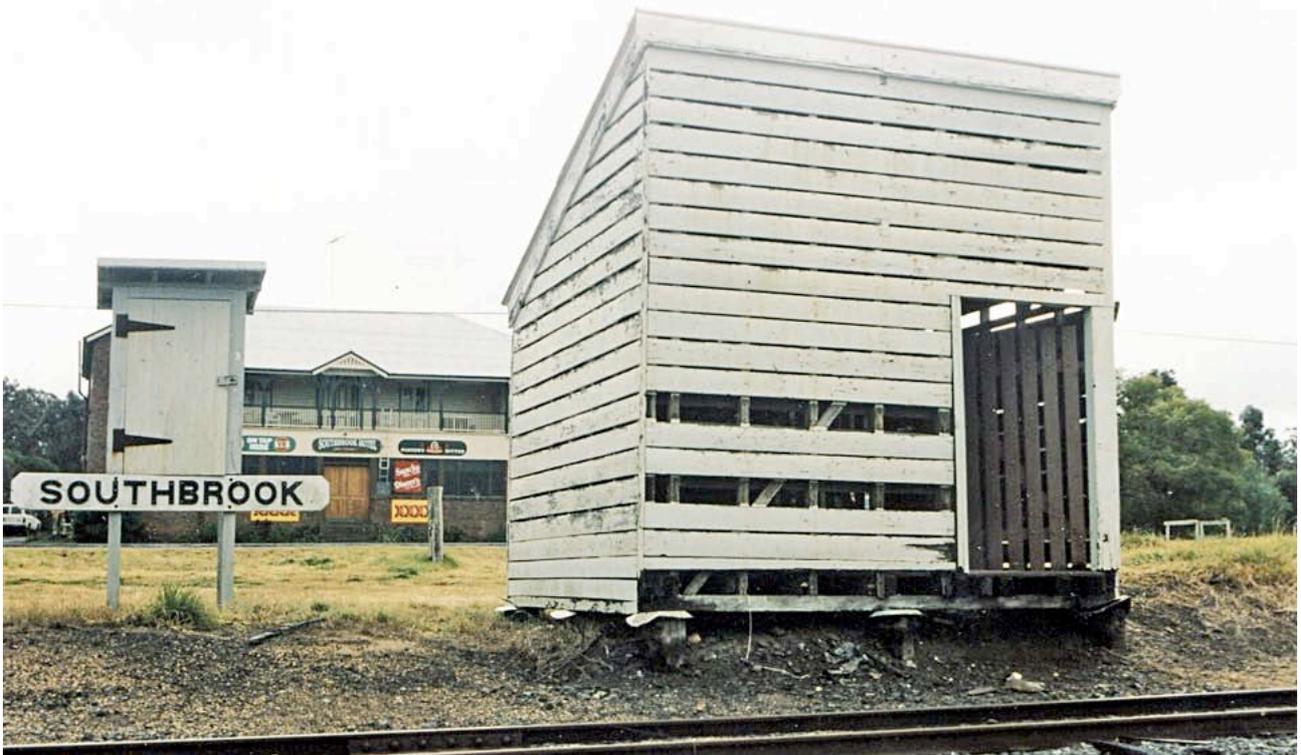
The occasional small non-standard shed could also be found from time to time, the unusual skillion-roofed shed at Southbrook, on the Millmerran branch, being one such example.

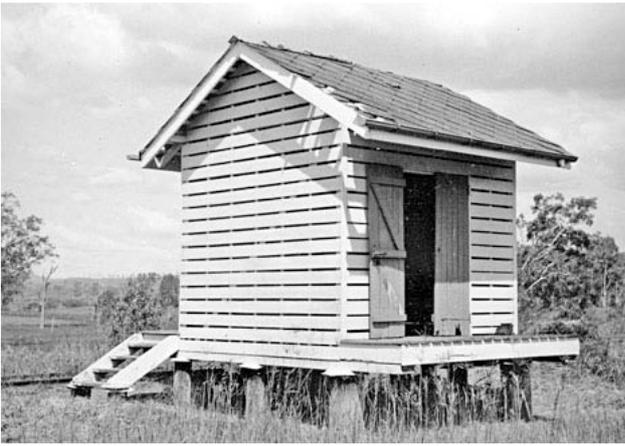
Nurinda on the Brisbane Valley branch, exemplified the typical standard cream shed, but it was also one of the less common structures to feature a 'fibro' slate roof.

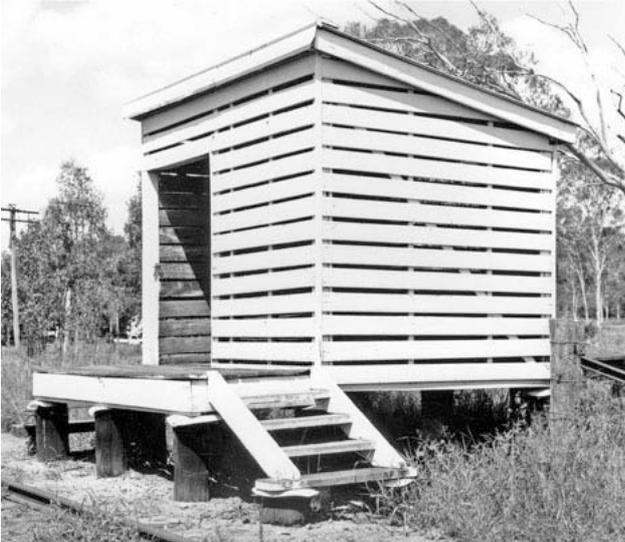
The shed at Moore, further north on the same line, would have been one of the smallest sheds, being maybe no more than 7'0" square in plan.

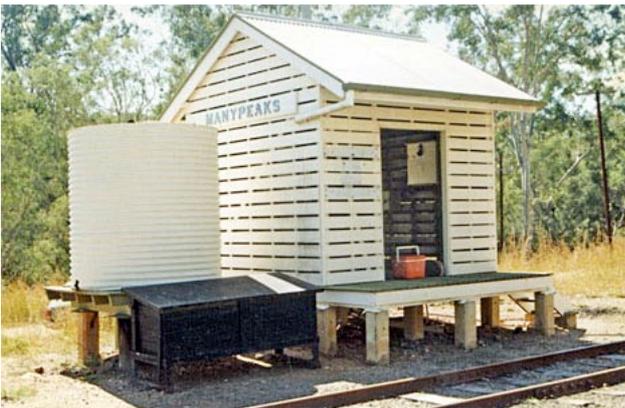
In 1996, along the Monto loop, Many Peaks' cream shed remained as the only railway building, apparently fulfilling the role of goods shed (and any other function). An accompanying tank was a common feature of these structures throughout the system.

The Many Peaks cream shed sat disassembled for several years but was restored as the Bundaberg Railway Historical Society's major project for 2005.

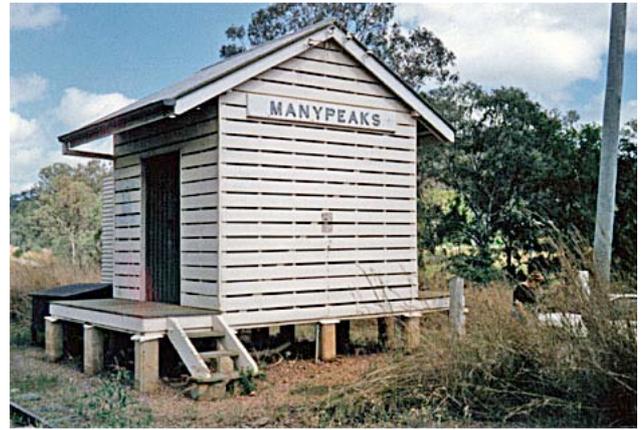
The opposite end of the Many Peaks cream shed some time prior to its removal to North Bundaberg. Note the diagonal bracing visible under the siding. The gray patch on the side appears to be the location of a power panel; the electrical conduit is visible to the left of the stump. Bundaberg Railway Historical Society photo.

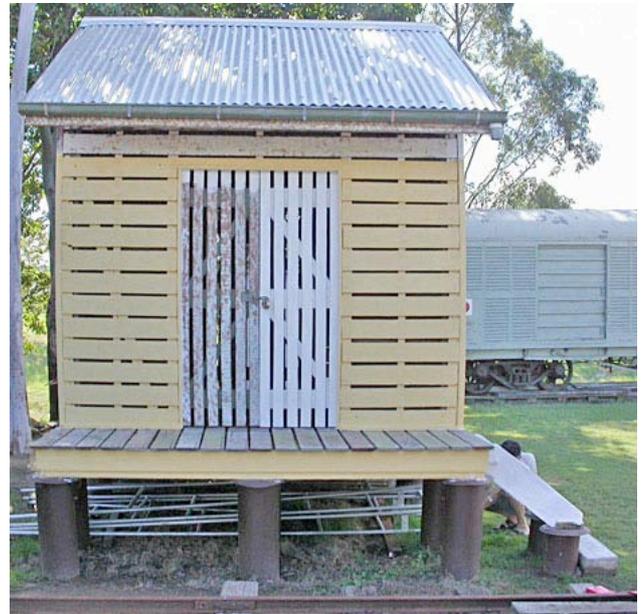
When the building was reassembled it was apparently installed back to front on the stumps, however both back and front appear to be reasonably identical. Lynn Zelmer photo 2005 during restoration.

Dimensions were obtained during restoration. The building itself is square (10' 2" x 10' 2") on a 10' 2" x 16' 6" platform (platform floor boards extend roughly 1" over the edge, increasing the apparent dimensions slightly). The timber for construction of such buildings was painted but not planed and any smoothing came from wear. Exterior wall boards are 1" x 6" with a 1" space between. Interior wall boards appear to be 1" x 4" or 1" x 3" and are placed so that they cover the exterior openings.

The door opening is 3' 9" x 6' 5". Vertical door slats are 1" x 3" with a nominal 1" spacing. The building's height and other dimensions should be able to be scaled accurately enough for modelling purposes from the end views on the next page.

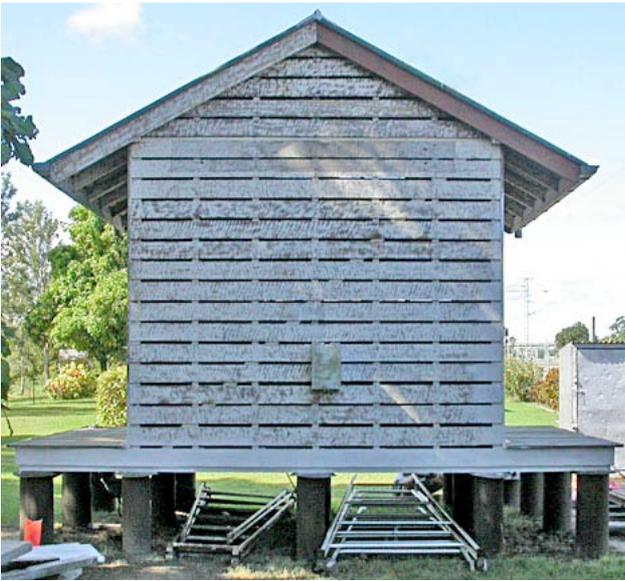
End view during restoration, 2005. This is the opposite end to the water tank in the original site due to the shed being turned around during restoration. Lynn Zelmer photo.

The building was undercoated in white and then painted in QR yellow to match other museum buildings. Downspouts and the restored station sign, etc., have also been fitted.

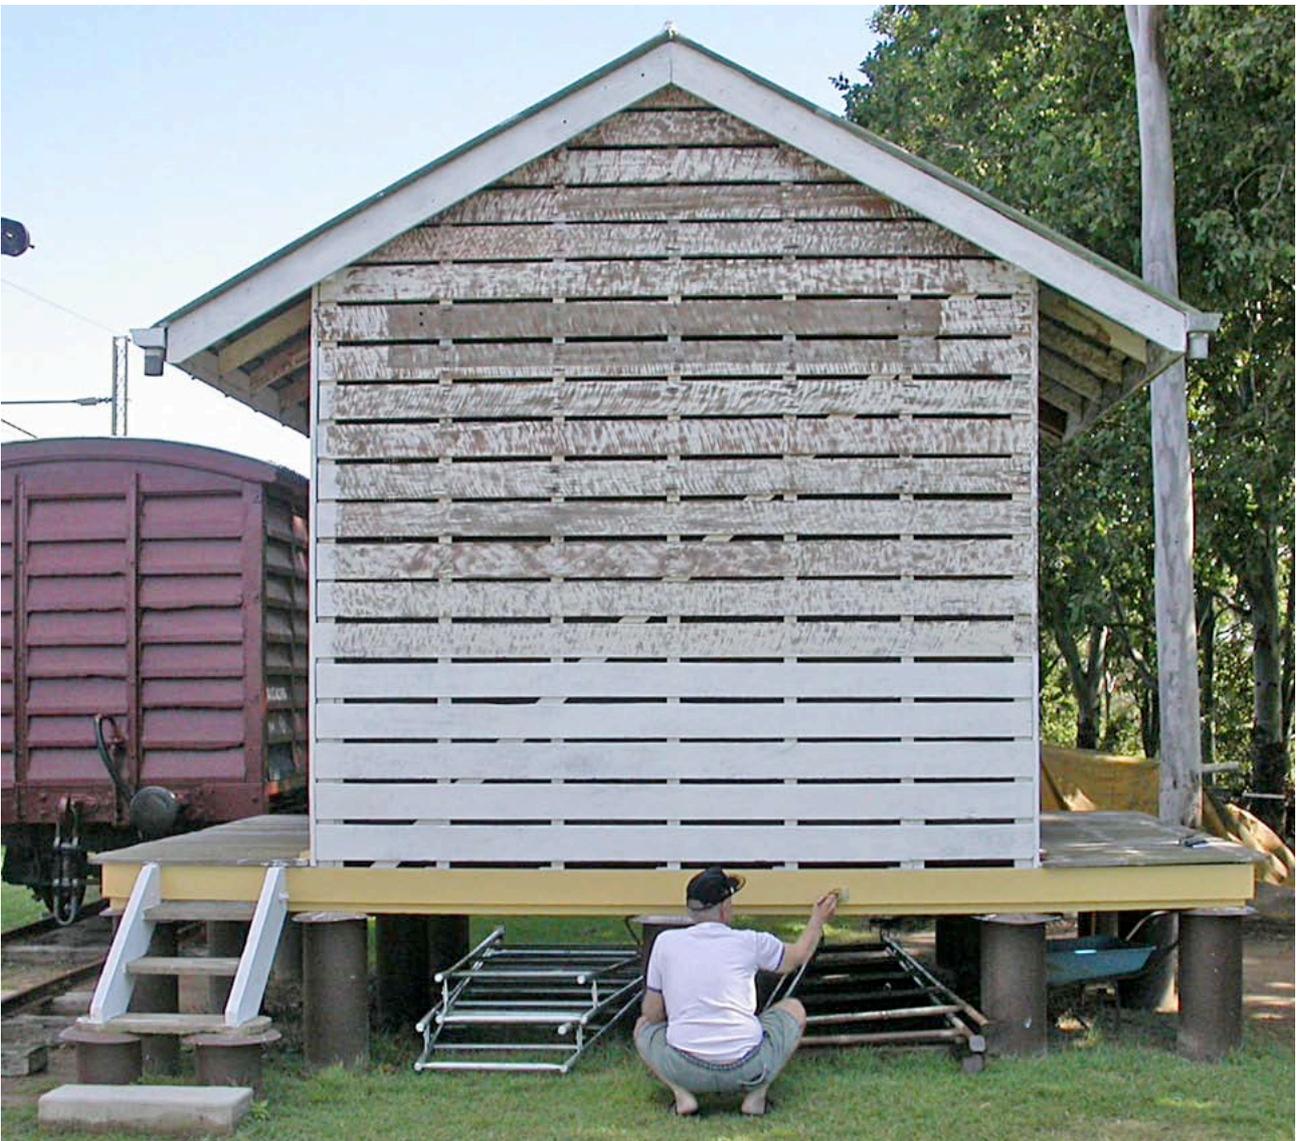
Note the location of the name board and the width of the diagonal brace, likely 1" x 3" timber inset into the vertical studs. While the exterior of the building (and outside edge of the studs, etc.) was painted white, the interior timber had either been painted a dark colour or had weathered dark. Lynn Zelmer photo, 2005.
