## Douglas Shire Tramway Train Control Staff

**Greg Stephenson, ANGRMS**

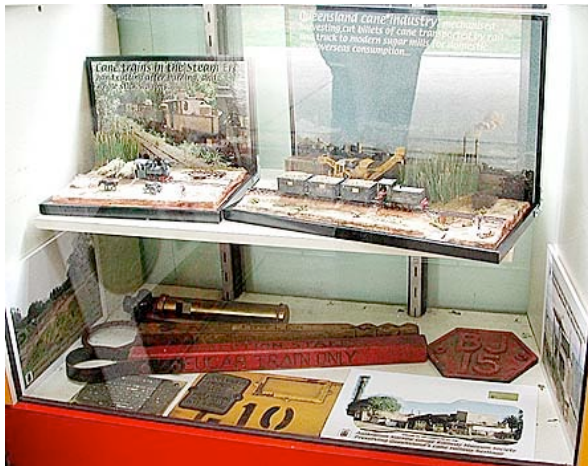
The Douglas Shire Train Control Staff on the lower shelf of an ANGRMS display case.

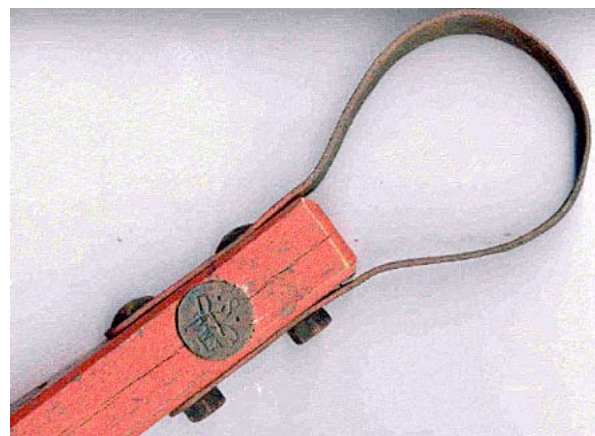
- Discolouration of the paint – probably caused by handling during use by train crew with greasy hands
- There is a surface crack on the front face. This appears to be a typical drying check in the timber and the in-ground dirt suggests that it may have originated early in the life of the staff. The object was originally used in Mossman in tropical North Queensland, and is now located in a temperate area, so the change in conditions (lower temperature and relative humidity) may have contributed to "opening up" of the crack.
- During cleaning, small balls of cobwebs were found in some of the carved letters which might indicate a lack of pest control.

- The chips in the paint are expected to have originated from the original use of the object as it would have been hung up on the loco by the iron loop.
- The iron handle has mild surface rusting but this appears stable, an indication of current relatively mild display conditions.
