This note shows two shed designs with detailed photos from Mount Morgan in Central Queensland. John Armstrong's plan on the page 3 represents a single bay shed from early in the 20th century but general construction techniques are similar to the more recently built sheds.

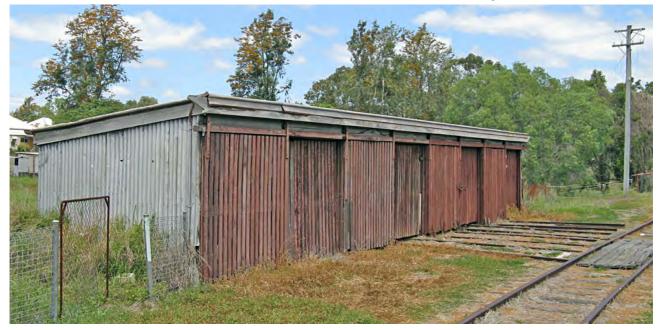
South end of the Mount Morgan fettler's shed, October 2008. Note the shape of the facia board end and the painted sheathing. A door lock can be seen at the top of the first door, the lock on a door further along is at waist level..

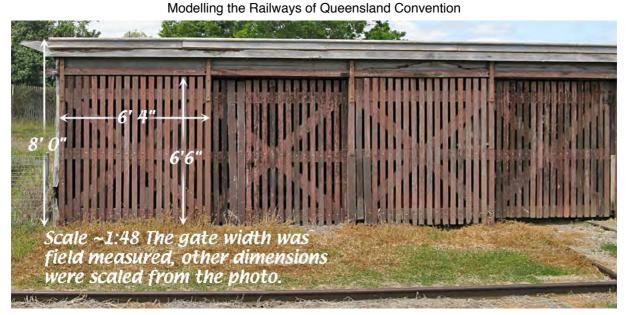
The fettler's shed at Mount Morgan now has tracks to only four of its eight bays. All Mount Morgan photos Lynn Zelmer photographer, 2008. A photorealistic model based on this shed is described in a July 2012 *Narrow Gauge Downunder* article. It's also available as a free download from http://QldRailHeritage.com/mrqc/.
